HOUSATONIC RIVER BASIN  
WASHINGTON, MASSACHUSETTS

WASHINGTON MOUNTAIN LAKE DAM  
MA 00318

PHASE I INSPECTION REPORT  
NATIONAL DAM INSPECTION PROGRAM

DECEMBER 1979

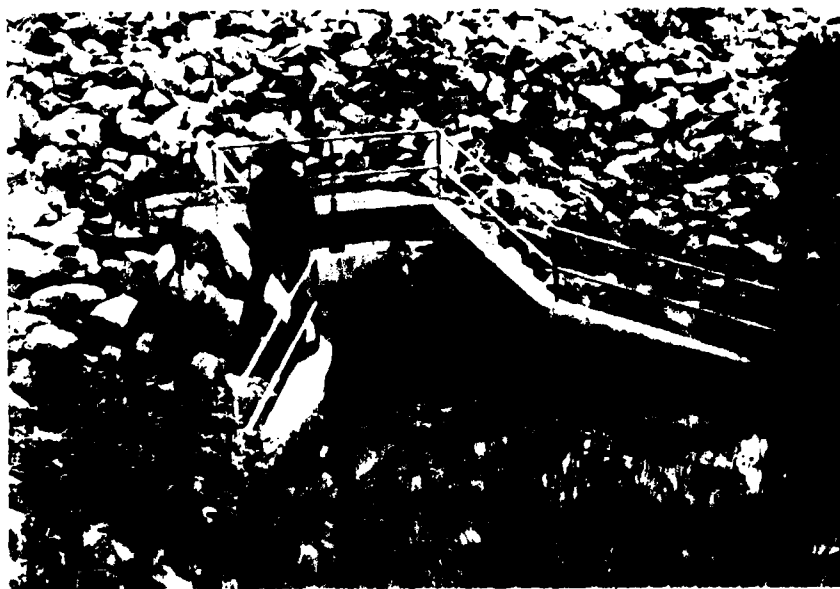
The downstream channel is a narrow channel passing over a shallow sloping area. The channel is stable and the area around the impact basin is in good condition.

Photo 13 - View of impact  
basin structure looking  
northeasterly from down-  
stream.
